## ***I-Leak-Pro or Leakage current***

Leakage current failure: faults and possible causes as well as ways to prevent the issue. We will look at a real-life installation example to demonstrate the ways this common fault can be prevented.

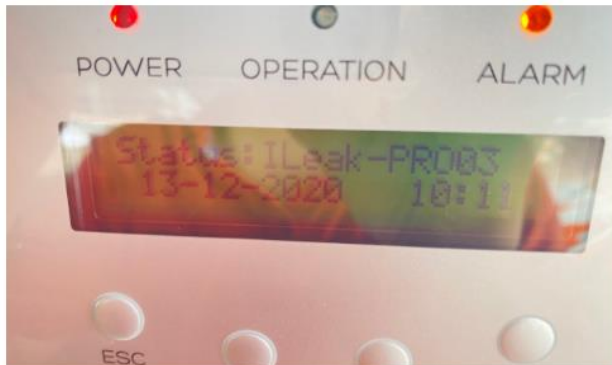
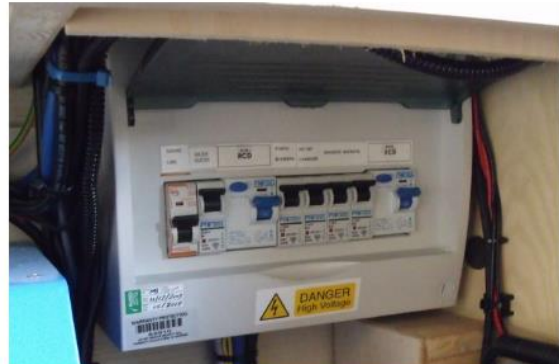
A likely cause is that the inverter is disconnected from the grid, entering the protection mode with the inverter screen displaying the error message of "ILeak-PRO 01/02/03/04". This could then trigger the leakage protection device if the system has such a device installed.

- 1) Alarm code "ILeak-PRO 01", indicates a sudden leakage current of the system exceeding 30mA
- 2) Alarm code "ILeak-PRO 02", indicates a sudden leakage current of the system exceeding 60mA
- 3) Alarm code "ILeak-PRO 03", indicates a sudden leakage current of the system exceeding 150mA
- 4) Alarm code "ILeak-PRO 04", indicates the system has a continuous leakage current

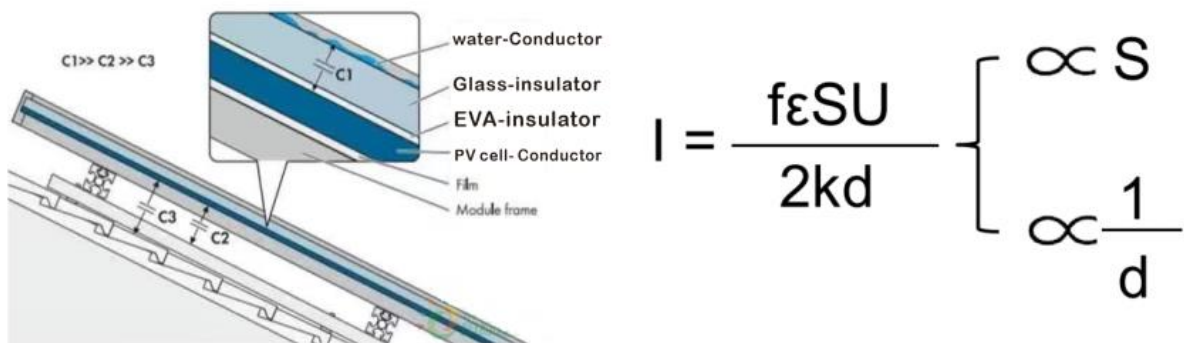
It is also known through field tests that the air humidity (medium  $\epsilon$ ) has a great influence on the stray capacitance of the system. It is easy to tell from the formula for leakage current (shown above) that the larger the PV panel area( $S$ ) , the higher the conductivity( $\epsilon$ ) of air , and the shorter the distance( $d$ ) between the PV panel and ground or roof , the higher the leakage current will be. This is the reason why commercial solar PV projects, especially when the solar panels are "carpet" installed on galvanized steel roofs, it tends to trigger the current leakage alarm.

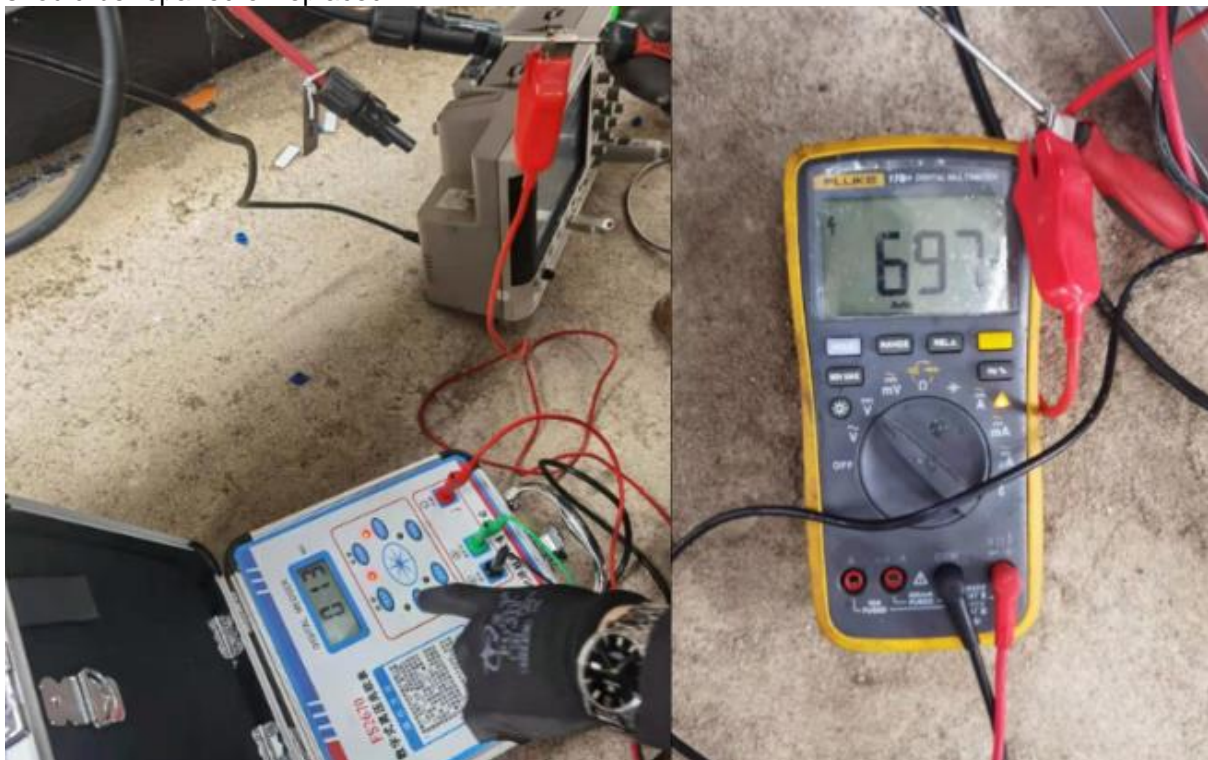
① Cable: If the cable sheath is damaged, it is easy to leak electricity when the air humidity is high.

Troubleshooting: Use a multi-meter or a meg-ohmmeter. If a cable with poor insulation is found, it should be repaired or replaced.

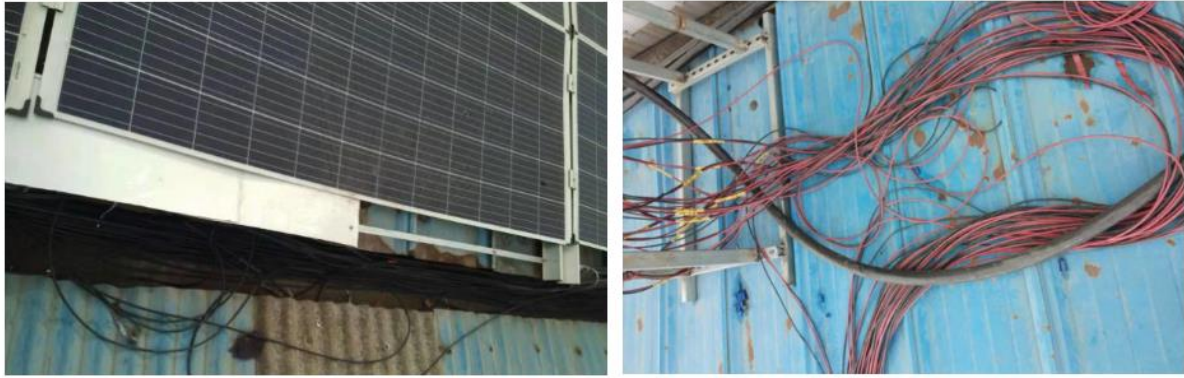
② Poor cable installation: Cable is directly installed on a roof without PVC pipe protection. When water accumulates on the roof, it is prone to short-circuit or current leakage. See images below.

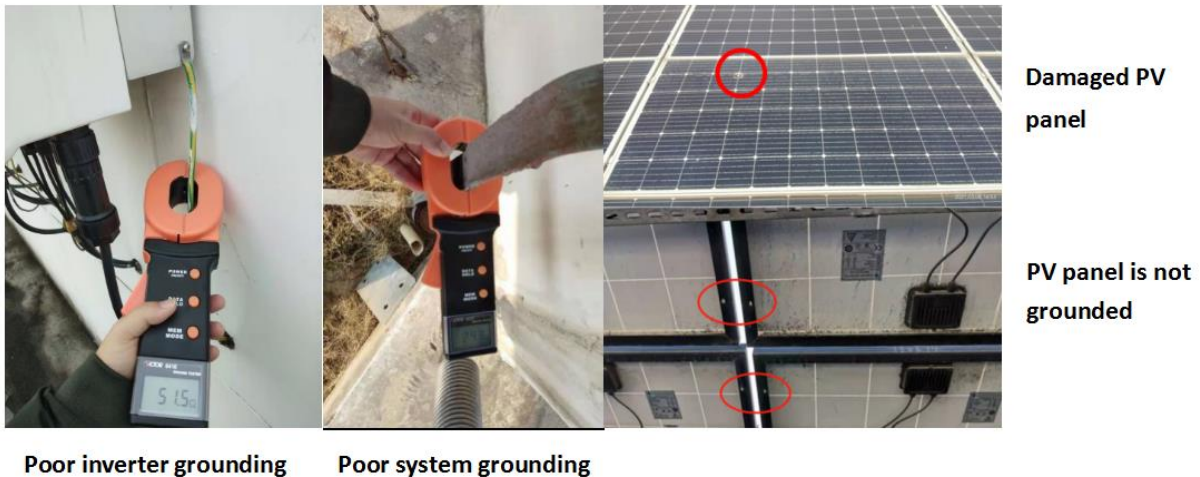
③ Poor grounding: Good grounding has two functions. The first is to effectively release the capacitive leakage current of the system to avoid excessive accumulation; the second is to ensure the safety of the system. If the grounding is sufficient and a leakage incident occurs, the leakage current will be sent to earth and will not cause an electric shock.
