## ***I-Leak-Pro or Leakage current***

Leakage current failure: faults and possible causes as well as ways to prevent the issue. We will look at a real-life installation example to demonstrate the ways this common fault can be prevented.

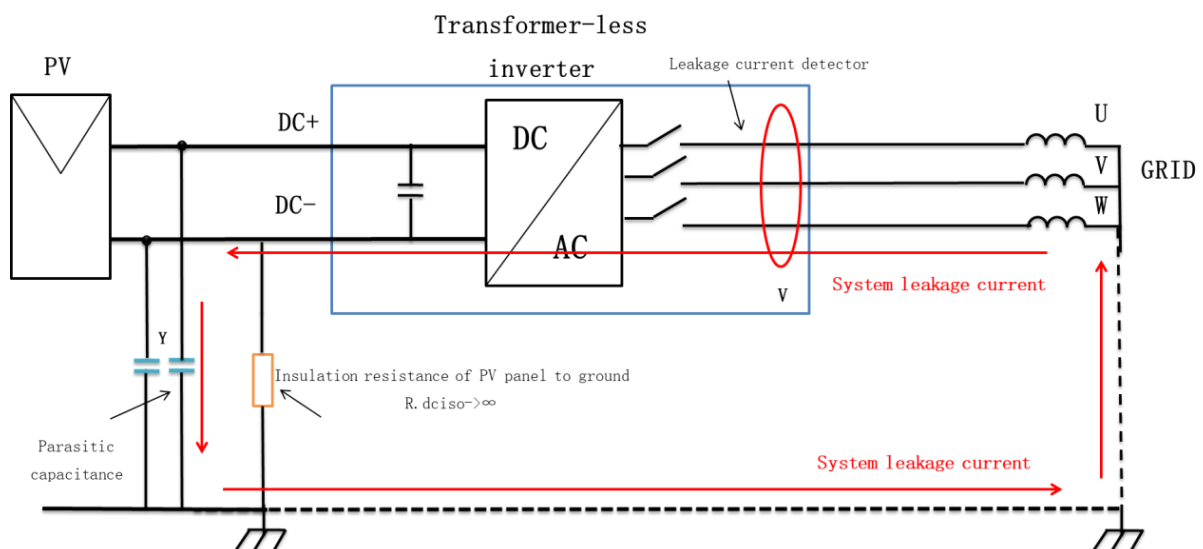
**Likely Reason:** This fault indicates that the inverter and the leakage current protector have detected leakage current from the PV system to the ground.

**In such cases, the safety regulations require that the inverter must stop generating and enter the protection mode to protect the safety of people and equipment.**
