Solis Firmware Update

Author: Travis Snyder V2

DSP Update

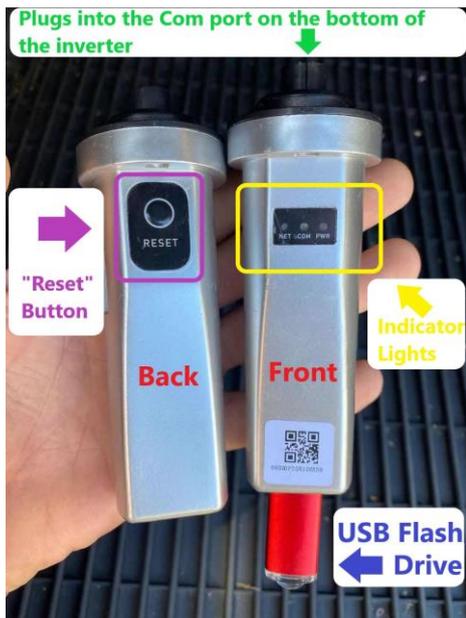
1: Update Stick:

Please contact Solis Support, if you do not have an Update stick yet. (Please note that sticks are only send to installers, not end customers.)

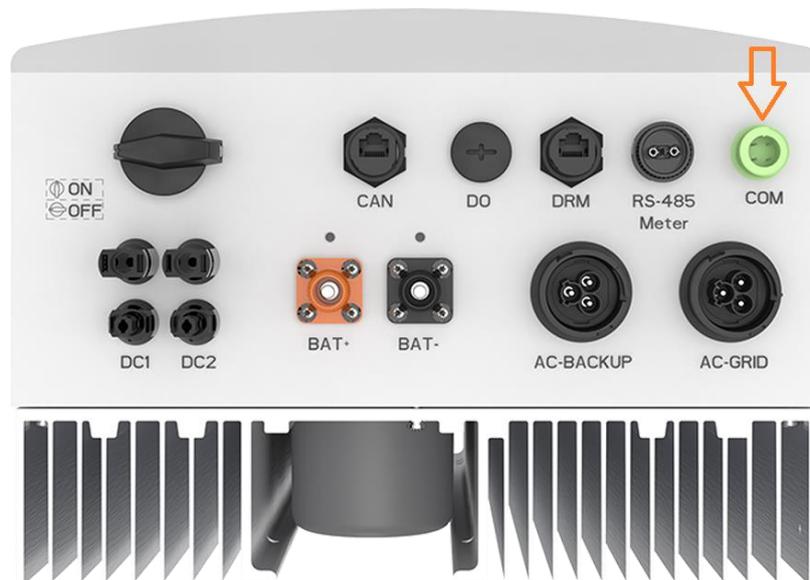
2. Place the USB into the Firmware Update Tool and place into the inverter's 4 pin Green Port.
Note: Example image is the 1 Phase RHI series. The COM port is on most inverters identical.
(Except for our S6 series, which have an USB connector)

3. The Firmware Update Tool Should Light RED and GREEN as seen in the picture.
